3. Overhead Line Equipment

4. Formation and Structural Failures

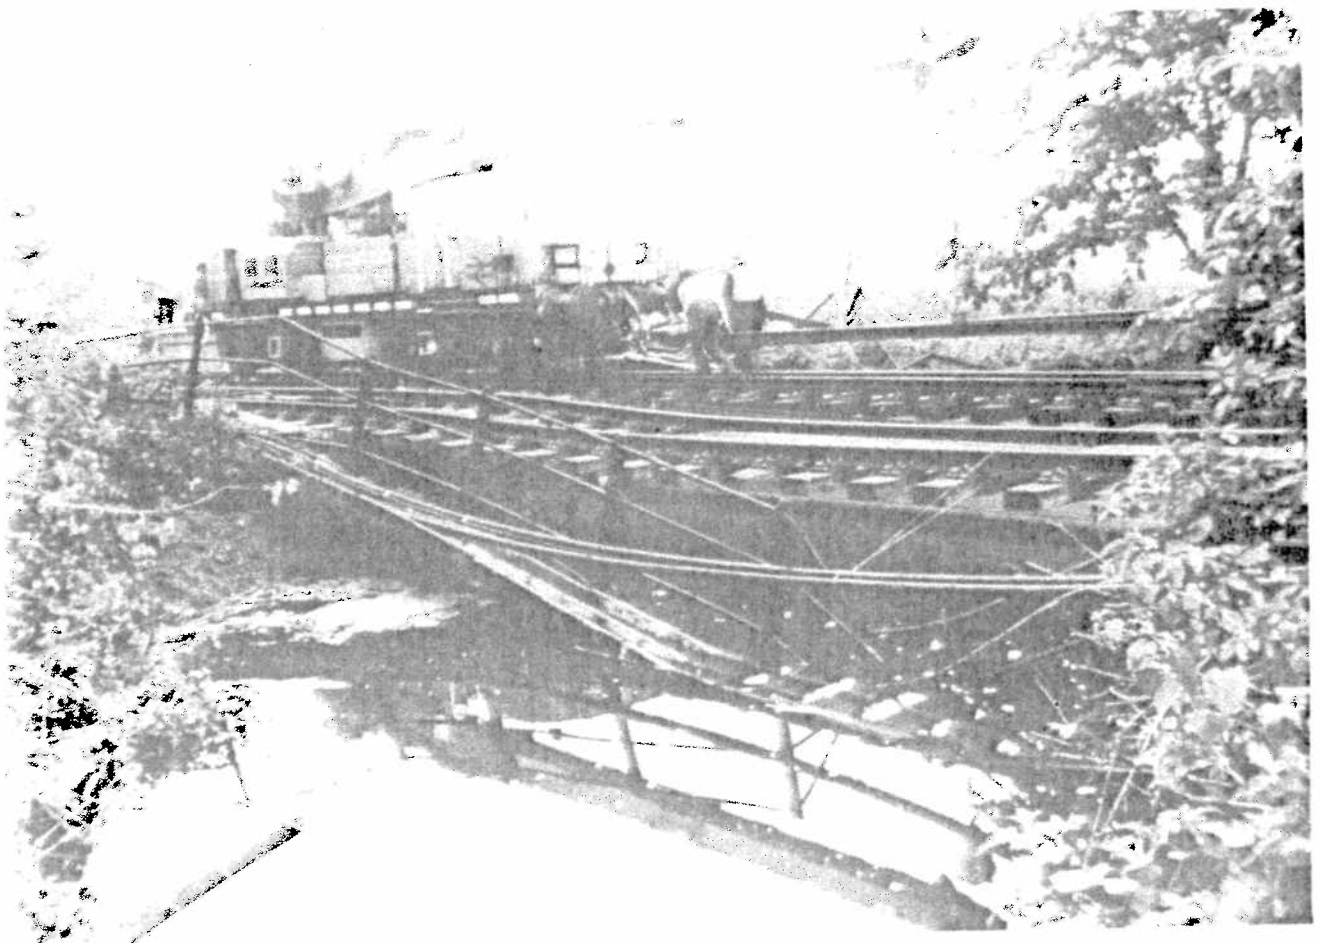
4.2 Although not classified as a failure but as a train accident because of the resultant derailment of an ECS passenger train (see Chapter III), the collapse of Bridge No 71 between *Wraysbury* and *Sunnymeads (SR)* on 10 May was potentially the most serious failure of a structure. Bridge No 71 was one of three adjacent bridges which carried the double track line over three

Collapse of a bridge between *Wraysbury* and *Sunnymeads (SR)* on 10 May. (Photograph by courtesy of British Railways.)

separate water courses. It comprised three trough girder spans each of approximately 3m resting on abutments and two piers built of brick that were founded on sandy gravel overlaid with a thin alluvial clay.

4.6 In the early part of 1988 the flows in the watercourses were considerably higher than usual. Serious flooding was occurring in the fields upstream of the railway. Heavy but localised rain storms on 7 and 8 May created extremely high flows. A breach of the bund between the Horton Ditch Diversion and the gravel workings occurred allowing water to flow directly into the excavation. The velocity of flow occasioned by the head difference of some 8m and the volume of water flowing caused rapid erosion of the gravel slope back towards the railway and Bridge No 71. The bridge failed when the erosion undermined the bridge foundations.

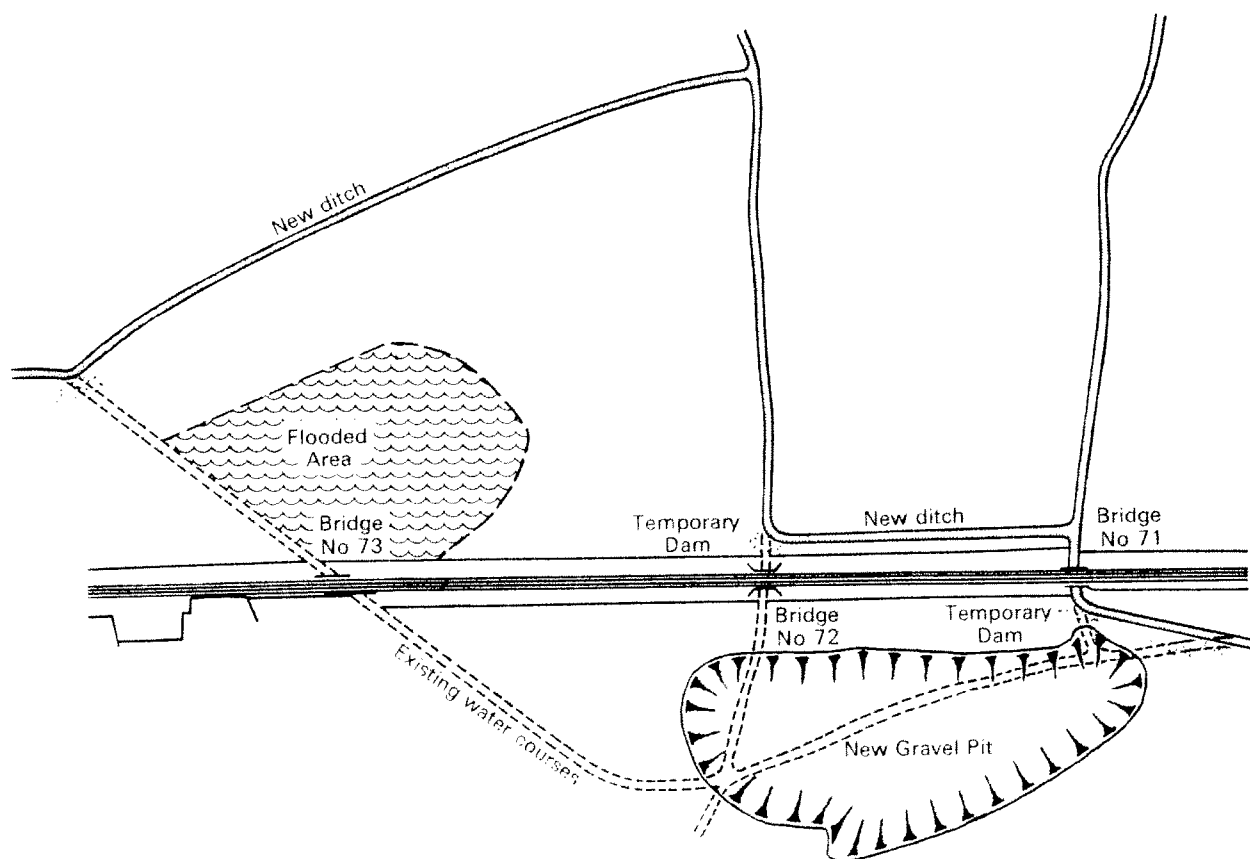
4.4 In order to extract the gravel, it was foreseen that diversions were required to be made to the water courses and these were specified in the approved Method of Working. However, during the course of the work, further unsanctioned diversions to the water courses also appear to have been made. Downstream of Bridge No 71, one water course had been diverted into a new ditch, known as the Horton Ditch Diversion that was constructed parallel to the railway and within the 15m wide strip, joined the stream that had flowed under

Bridge No 71 and the confluence was diverted into the lower end of the Horton Ditch Diversion. In February 1988, the Horton Ditch Diversion was overtopped which caused a land slip into the gravel pit.

4.5 A new channel was cut to divert the flow of another water course into the channel upstream of Bridge No 71. Excavation of the area adjacent to Bridge No 71 commenced in October 1987 and dewatering of the pit was effected by a submersible pump.

Simplified drainage layout at time of collapse of Bridge no 71 between Wraysbury and Sunnymeads.
